REPORT DOCUMENTATION PAGE		READ INSTRUCTIONS BEFORE COMPLETING FORM
1. REPORT NUMBER	2. GOVT ACCESSION NO. AD-A208252	3. RECIPIENT'S CATALOG NUMBER
4. TITLE (and Subtitle) National Program of Inspection of Non-Federal Dams, Tennessee. Lambert Dam (Inventory Number TN 00901) near Six Mile, Tennessee, Blount County, TN., Little Tennessee River Basin		5. TYPE OF REPORT & PERIOD COVERED Phase 1 Investigation Report

20. ABSTRACT (Continue on reverse side if necessary and identify by block number) Lambert Dam is a linear earthfill structure 605 feet long and 53 feet high with a crest width of 18 feet. The upstream and downstream slopes are 1V on 3.8H and 1V on 3.4H respectively. It has a capacity of 336 acre-feet at normal pool and 454 acre-feet at the top of the dam. The principal spillway consists of a 2.5 feet by 7.5 feet (ID) reinforced concrete riser which feeds a 30 inch diameter outlet pipe. Drawdown of the reservoir is controlled by a 24 inch square sliding headgate. The emergency spillway is an uncontrolled saddle type located just upstream of the right abutment. It runs parallel to the crest and

OVERVIEW
LAMBERT DAM

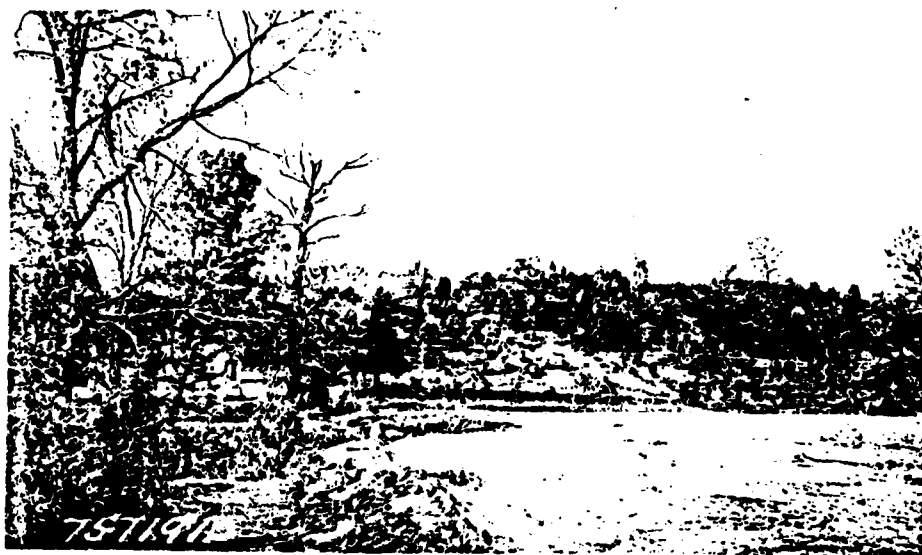
(a) Looking upstream on Six Mile Creek from Montvale Road. Note wash and highwater marks 2300 feet downstream from Lambert Brother's Dam.

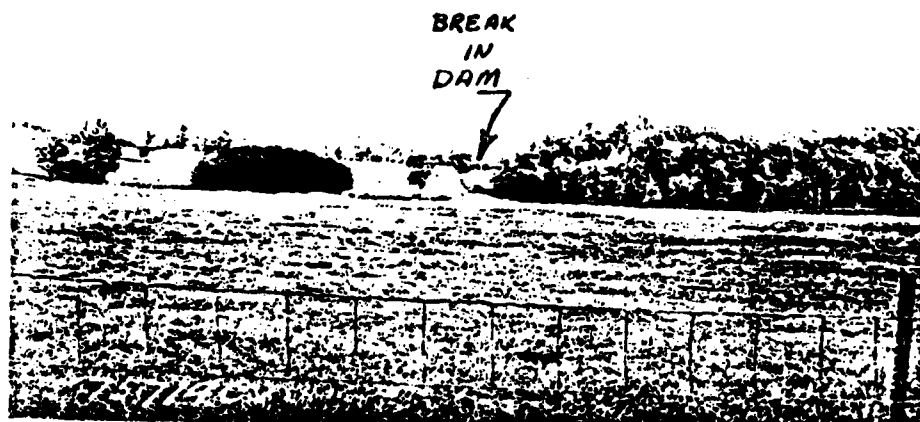
(c) Looking east and upstream at break in dam, center background, from Montvale Road.

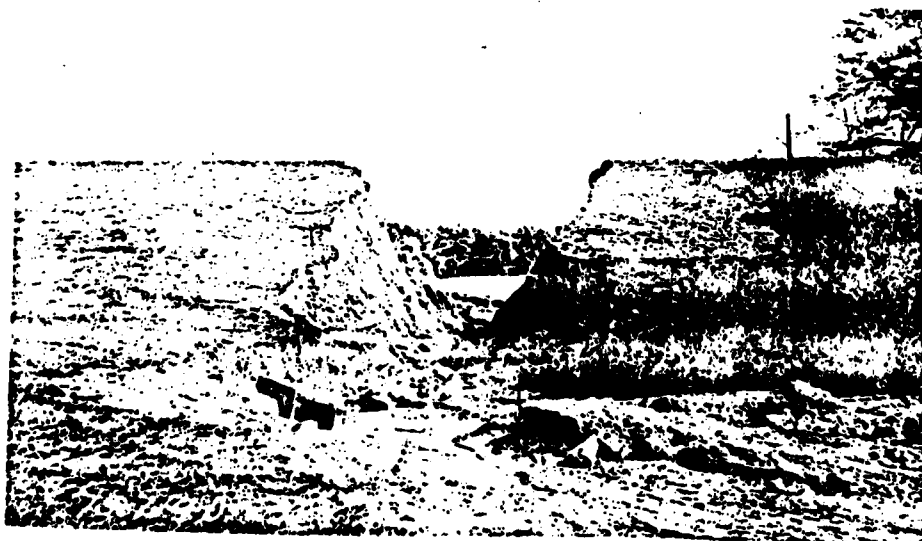
(d) Looking upstream at break in dam. Note a portion of vertical morning glory type overflow section at left center.

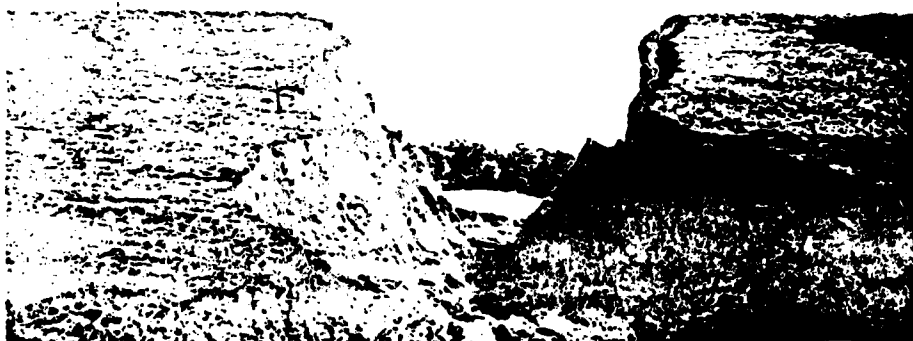
(e) Close-up view of break in Lambert Brother's Dam as seen from downstream.

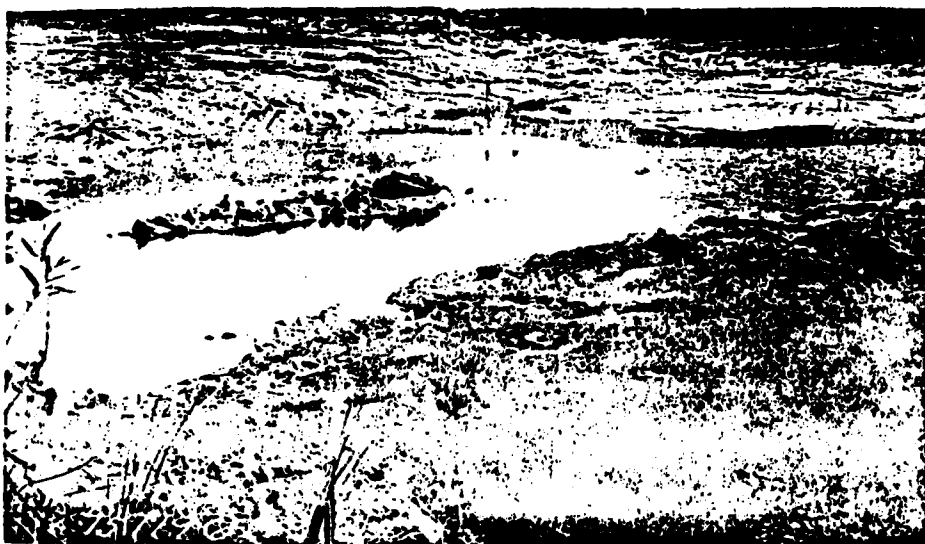
(g) Looking from the top of the Lambert Brother's Dam at the break on the upstream side and remaining pool.

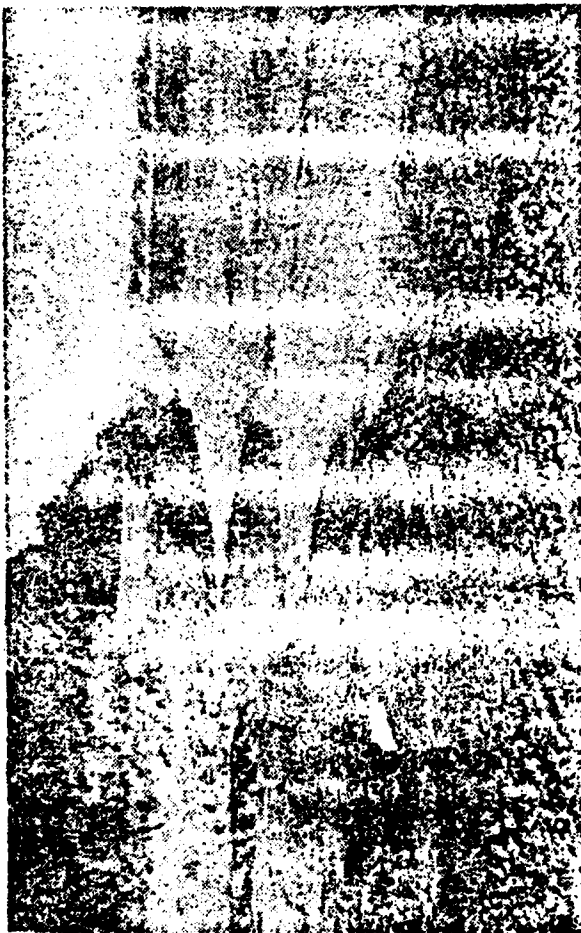
WHERE DAM BROKE — Arrow in aerial view (left) by Soil Conservation Service shows point where break occurred Saturday night in dam on Lambert Brothers farm. Large sycamore tree near point of arrow was

swept away by the water. At right is view from behind dam after the break in background. Two men, tiny specs near dam (background) were picking up fish. When water receded, tracks made seven years ago by

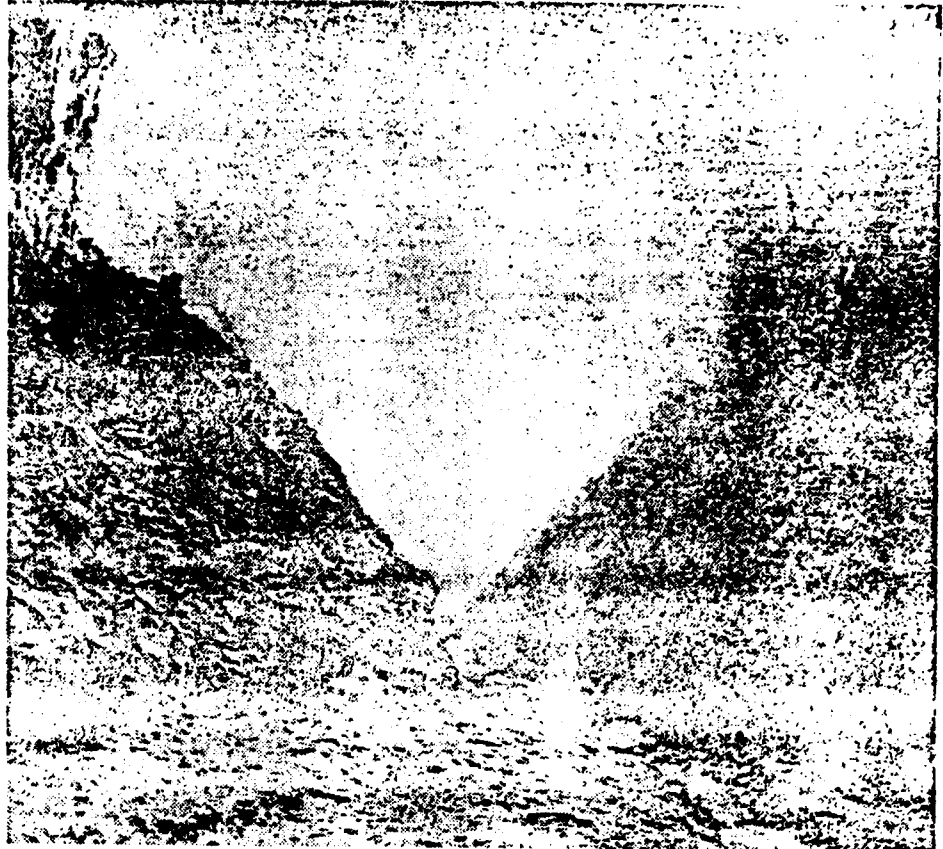
BREAK IN DAM — About 35 feet wide at the top is this break in the 47-foot high dirt fill dam at the 17-acre lake on Lambert Brothers farm at Six Mile on Montvale Road.
